# Inspection Report

Site Name Sample Report

Site Location Sydney Australia

Date 26/05/2026

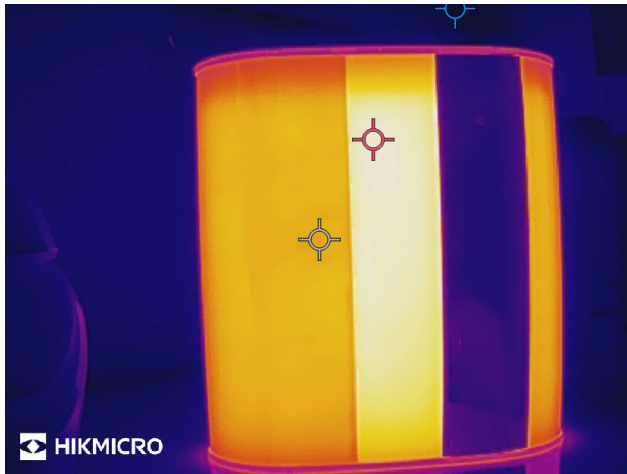
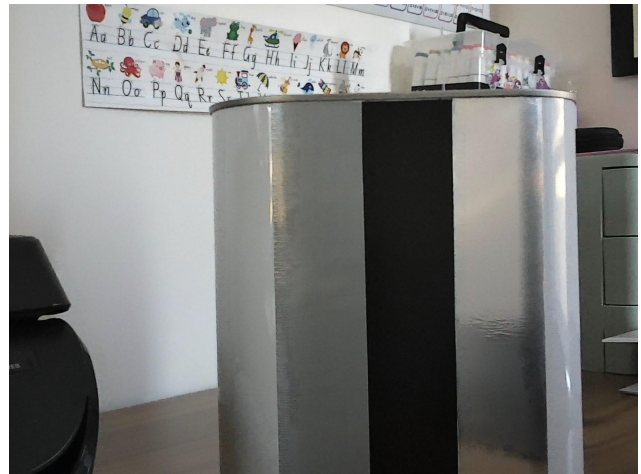
2025-09-30 16.06.27

| Image: Max. Temp. | 60.0°C |

| Fault Rating | No Action Required |

Thermal inspection of the switchboard was conducted under normal operating conditions at the time of testing

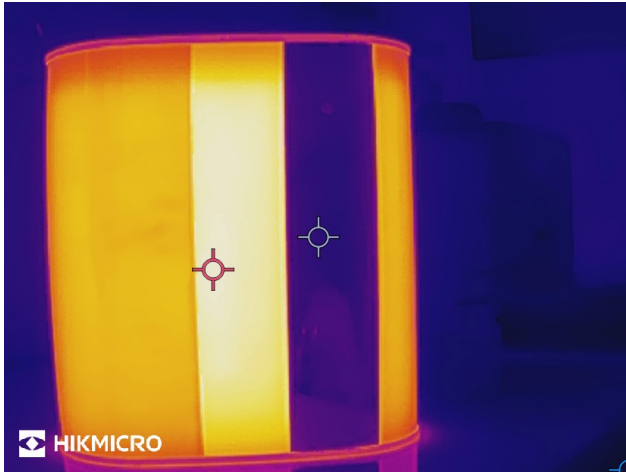
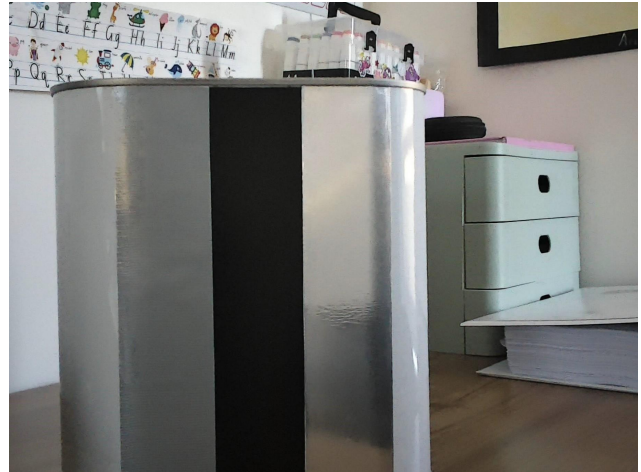
2025-09-30 16.06.05

Image: Max. Temp. 59.9°C  
Image: Min. Temp. 24.2°C  
Image: Center Temp. 27.3°C

Fault Rating [Potential Deficiency: Investigation Required](#)

Thermal inspection of the switchboard was conducted under normal operating conditions at the time of testing

| Fault Level | Temp Difference | Action |
|---|---|---|
| Potential deficiency | < 20–30 °C | Within limits. Repair at next shutdown ( $\leq 9$ months). |

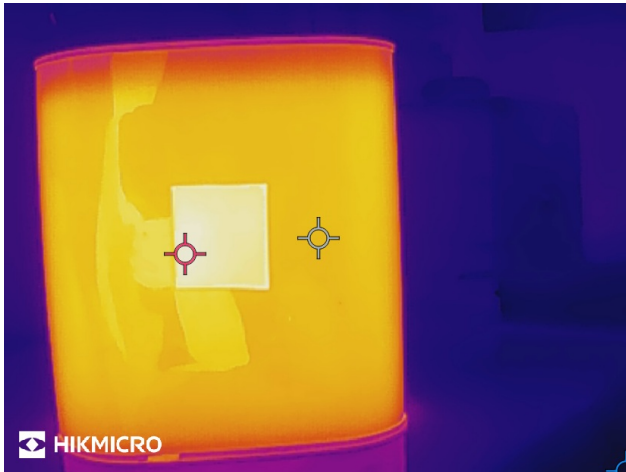
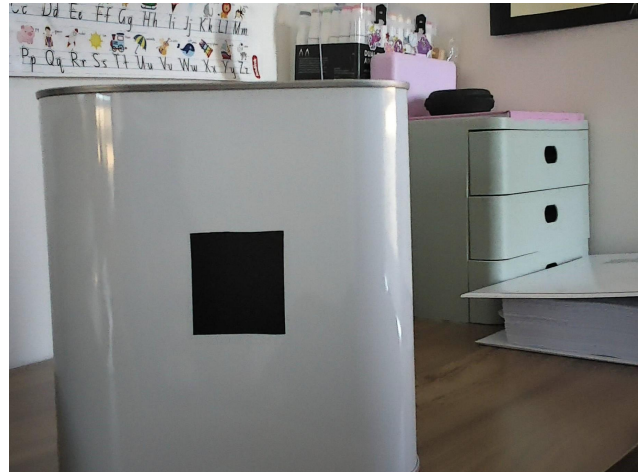
2025-09-30 16.06.58

Image: Max. Temp. 60.5°C  
Image: Min. Temp. 23.3°C  
Image: Center Temp. 54.8°C

Fault Rating Repair Required

Thermal inspection of the switchboard was conducted under normal operating conditions at the time of testing

| Fault Level | Temp Difference | Action |
|---|---|---|
| Repair required | 15–30 °C | Repair or reassess within 3 months. |

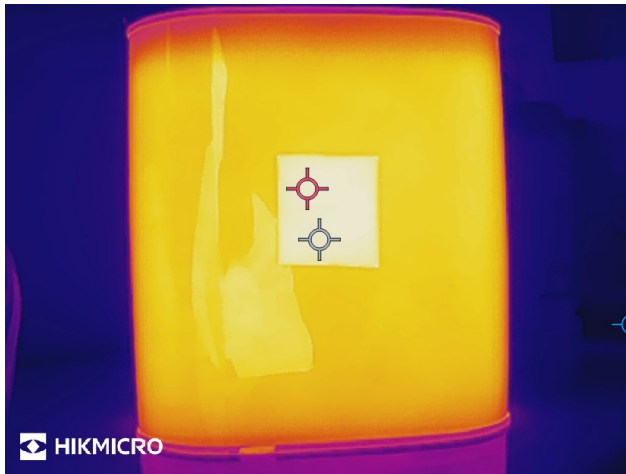
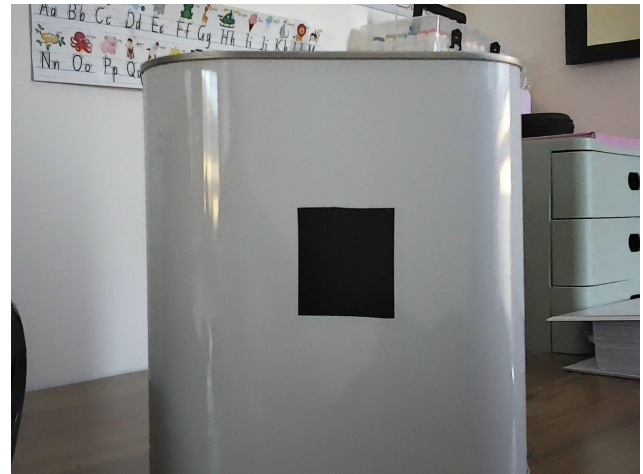
2025-09-30 16.06.44

Image: Max. Temp. 60.4°C  
Image: Min. Temp. 24.8°C  
Image: Center Temp. 60.2°C

Fault Rating **Immediate Repair Required**

Thermal inspection of the switchboard was conducted under normal operating conditions at the time of testing

Immediate action required – site rep informed.
